## Paint Defects

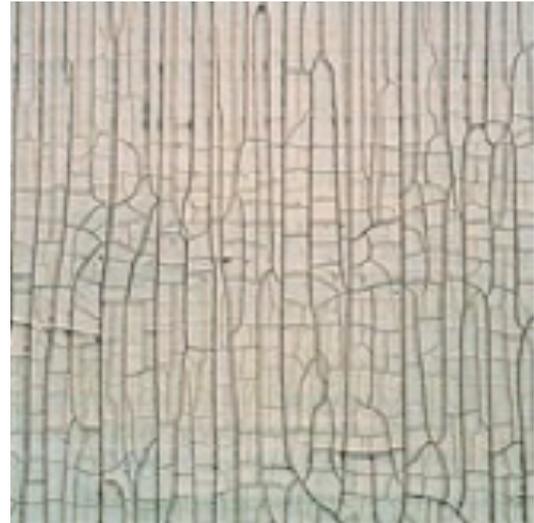
- Application of an extremely hard, rigid coating, like a solvent-based enamel, over a more flexible coating, like a water-based primer.
- Application of a topcoat before the undercoat is dry.
- Natural aging of oil-based paints as temperatures fluctuate. The constant expansion and contraction results in a loss of paint film elasticity.

**FIGURE 1. Patterned cracking in the surface of the paint film resembling the regular scales of an alligator.**

Old paint should be completely removed by scraping and sanding the surface; a heat gun can be used to speed work on large surfaces, but take care to avoid igniting paint or substrate. The surface should be primed with a high quality water-based primer, then painted with a top quality exterior water-based paint.

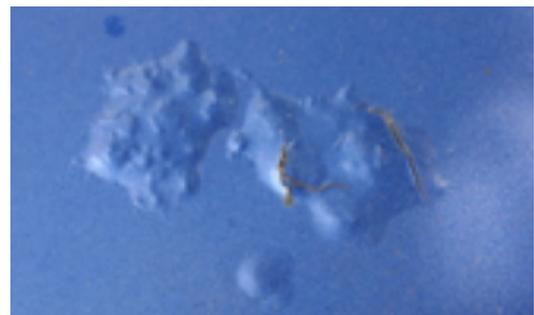
- Painting a warm surface in direct sunlight.
- Application of oil-based or alkyd paint over a damp or wet surface.
- Moisture escaping through the exterior walls (less likely with latex paint than with oil-based or alkyd paint).
- Exposure of latex paint film to dew, high humidity or rain shortly after paint has dried, especially if there was inadequate surface preparation.

**FIGURE 2. Bubbles resulting from localized loss of adhesion and lifting of the paint film from the underlying surface.**

If blisters go down to the substrate, first try to remove the source of moisture. Remove blisters by scraping, then sanding the surface. Prime any bare timber with a high quality water-based primer, and repaint with a high quality water-based exterior paint.

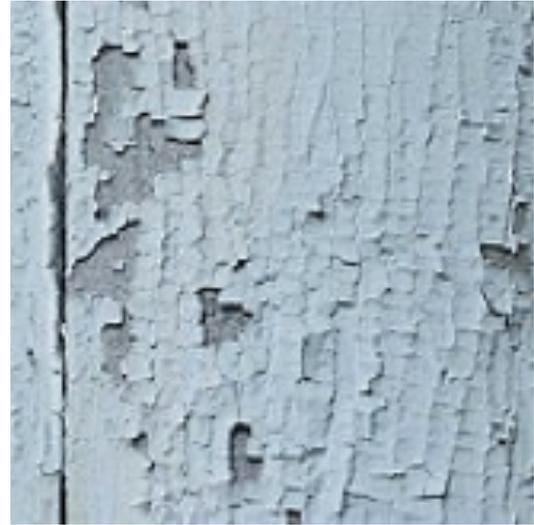
- Use of a lower quality paint that has inadequate adhesion and flexibility.
- Over thinning the paint or spreading it too thin.
- Poor surface preparation, especially when the paint is applied to bare timber without Gloss.

**FIGURE 3. Early on, the problem appears as hairline cracks; later, flaking of paint chips occurs. The splitting of a dry paint film through at least one coat leads to complete paint failure.**

It may be possible to correct cracking that does not go down to the substrate by removing the loose or flaking paint with a scraper or wire brush, sanding to feather the edges, priming any bare spots and repainting. If the cracking goes down to the substrate remove all of the paint by scraping, sanding and/or use of a heat gun; then prime and repaint with a quality exterior latex paint.

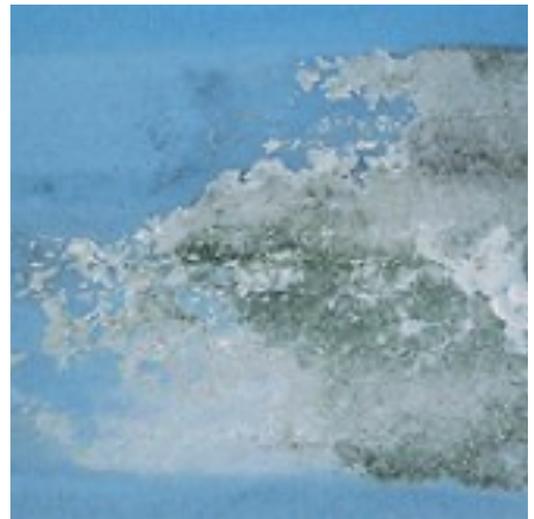
- Failure to adequately prepare surface by removing all previous efflorescence.
- Excess moisture escaping through the exterior masonry walls from the inside.

**FIGURE 4. Crusty, white salt deposits, leached from mortar or masonry as water passes through it.**

If excess moisture is the cause, eliminate the source by repairing the roof, cleaning out gutters and downspouts, and sealing any cracks in the masonry with a high quality, water-based all-acrylic caulk. If moist air is originating inside the building, consider installing vents or exhaust fans, especially in kitchen, bathroom and laundry areas. Remove the efflorescence and all other loose material with a wire brush, power brush or power washer; then thoroughly rinse the surface. Apply a quality water based or solvent-based masonry sealer and allow it to dry completely; then apply a coat of top quality exterior house paint, masonry paint or elastomeric wall coating.

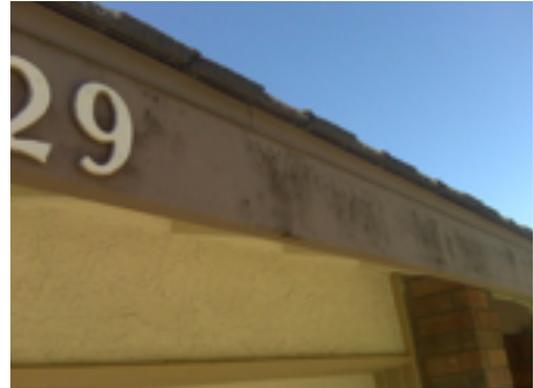
- Forms most often on areas that tend to be damp, and receive little or no direct sunlight (the underside of eaves are particularly vulnerable).
- Use of a lower quality paint.
- Preparation procedures as for new construction.

**FIGURE 5. Black, gray or brown areas on the painted surface.**

Test to distinguish mildew from dirt by applying a few drops of household bleach to the discolored area; if it disappears, it is probably mildew. Treat the mildew by applying a mixture of water and bleach, 3:1, and leave on for 20 minutes, applying more as it dries. Wear goggles and rubber gloves. Then scrub and rinse the area. Apply an exterior latex primer, then a top-of-the-line exterior latex paint in flat, satin, semigloss or gloss finish, depending on the desired appearance.

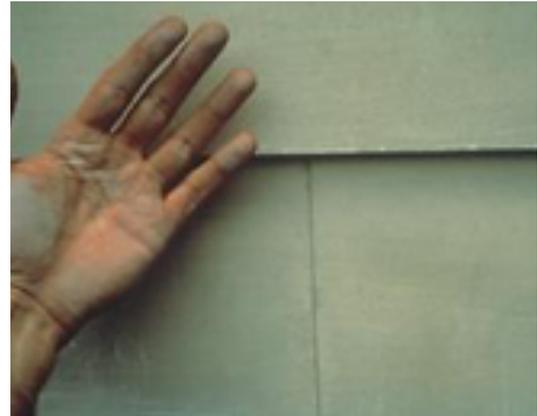
- Use of an interior paint outdoors.
- Use of lower quality paint.
- Use of solvent-based paint in direct sunlight areas.

**FIGURE 6. Formation of fine powder on the surface of the paint film during weathering, can cause color fading. Although some degree of chalking is a normal, desirable way for a paint film to wear, excessive film erosion can result in heavy chalking.**

First, remove as much of the chalk residue as possible, scrubbing with a stiff bristle brush (or wire brush on masonry) and then rinse thoroughly; or use power washing equipment. Check for any remaining chalk by running a hand over the surface after it dries. If noticeable chalk is still present, apply a quality oil-based or acrylic latex primer (or comparable sealer for masonry), then repaint with a quality exterior coating; if little or no chalk remains and the old paint is sound, no priming is necessary.

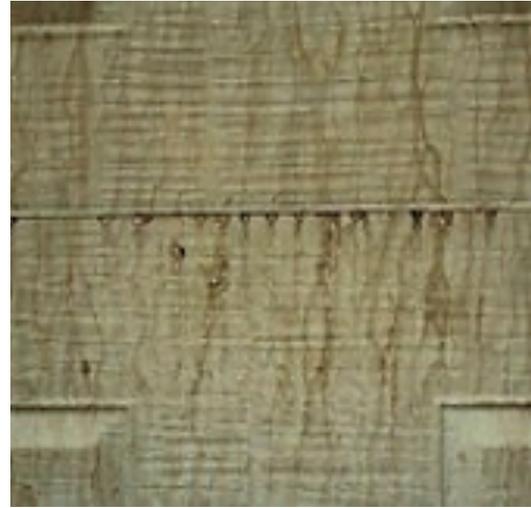
- Painting in cool, humid conditions or just before they occur. The longer drying time allows the paint's water-soluble ingredients — which would normally evaporate, or be leached out by rain or dew — to rise to the surface before paint thoroughly dries.
- Mist, dew or other moisture drying on the painted surface shortly after it has dried.

**FIGURE 7. Concentration of water-soluble ingredients on water-based paint, creating a blotchy, sometimes glossy appearance, often with a tan or brownish cast. More likely with tinted paints than with white or factory-colored paints.**

Avoid painting in the late afternoon if cool, damp conditions are expected in the evening or overnight. If the problem occurs in the first day or so after the paint is applied, the water-soluble material can sometimes be rinsed off rather easily. Fortunately, even more stubborn cases will generally weather off in a month or so. Surfactant leaching should not affect the ultimate durability of the coating.

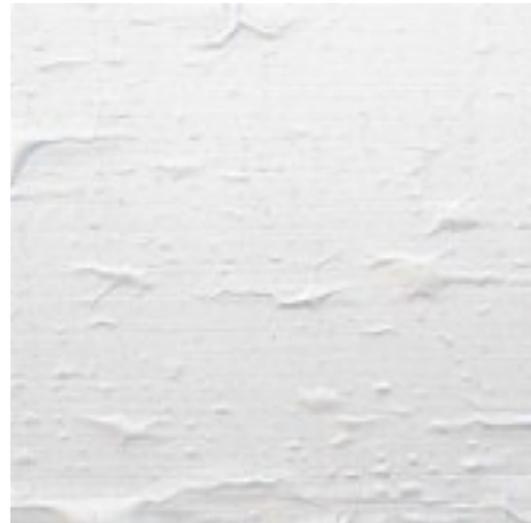
- Paint applied too thickly (more likely when using solvent-based paints).
- Painting a hot surface or in very hot weather.
- Exposure of uncured paint to rain, dew, fog or high humidity levels.
- Applying the topcoat to insufficiently dried first coat.
- Painting over contaminated surface (e.g., dirt or wax).

**FIGURE 8. A rough, crinkled paint surface occurring.**

Scrape or sand substrate to remove wrinkled coating. Repaint, applying an even coat of top quality exterior paint.

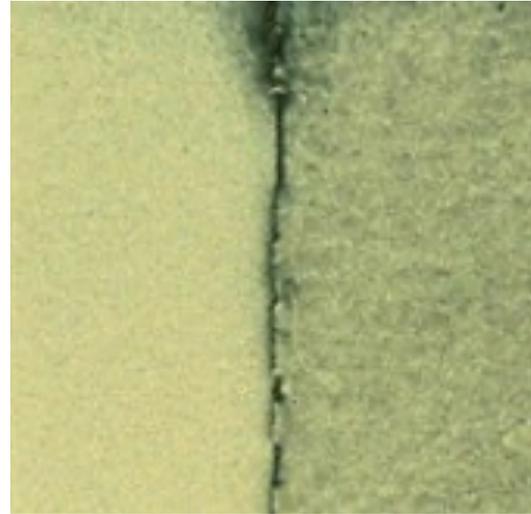
- Use of low quality paint.
- Soil splashing onto the substrate.
- Air pollution, car exhaust and flying dust collecting on house body and horizontal trim

**FIGURE 9. Accumulation of dirt, dust particles and/or other debris on the paint film; may resemble mildew.**

Wash off all surface dirt before priming and painting. If unsure whether the problem is dirt or mildew, conduct a simple spot-test (see Mildew). Clean off dirt with a scrub brush and detergent solution, followed by a thorough rinsing with a garden hose. Heavier dirt accumulations may require the use of a power washer. (Higher gloss paints are more resistant to dirt pickup than flat paints, which are more porous and can more easily entrap dirt.

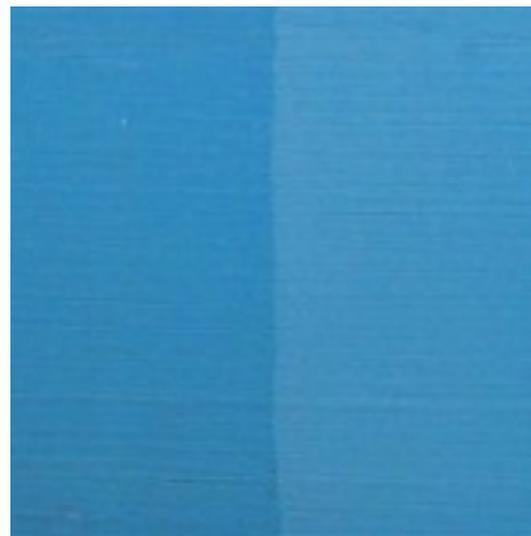
- Use of an interior grade of paint for an outdoor application.
- Use of lower quality paint, leading to rapid degradation (chalking) of the paint film.
- Use of a paint color that is particularly vulnerable to UV radiation (most notably certain bright reds, blues, and yellows).
- Tinting a white paint not intended for tinting, or over tinting a light or medium paint base.

**FIGURE 10. Premature and/or excessive lightening of the paint color, which often occurs on surfaces with sunny southern exposure. Fading/poor color retention can also be a result of chalking of the coating.**

When fading/poor color retention is a result of chalking, it is necessary to remove as much of the chalk as possible (see Chalking). In repainting, be sure to use a quality exterior house paint in colors recommended for exterior use.

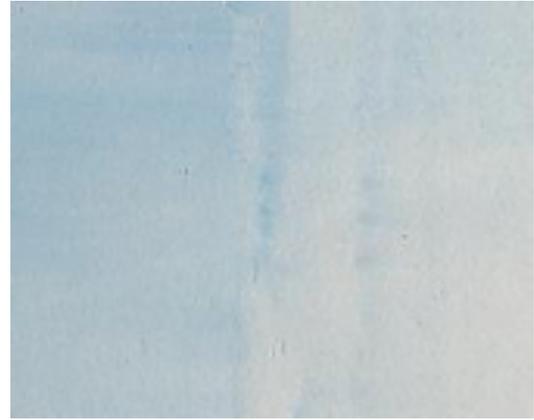
- Failure to maintain a 'wet edge' when applying paint.

**FIGURE 11. Appearance of a denser color or higher gloss where wet and dry layers overlap during paint application.**

Maintain a wet edge when painting by applying paint toward the unpainted area and then back into the just painted surface. This technique (brushing from "wet to dry" rather than vice versa) will produce a smooth uniform appearance. It is also wise to minimize the area being painted, and plan for interruptions at a natural break, such as a window, door or corner (especially important when applying stain to bare wood). Alkyd paints generally have superior wet edge properties.

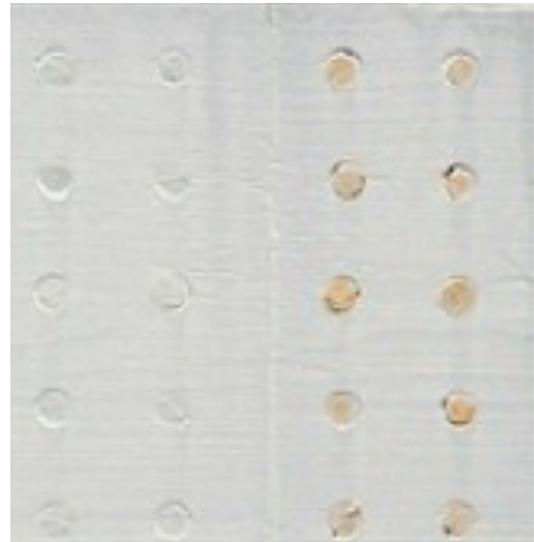
- Non-galvanized iron nails have begun to rust, causing bleed-through to the top coat.
- Non-galvanized iron nails have not been countersunk and filled over.
- Galvanized nail heads have begun to rust after sanding or excessive weathering.

**FIGURE 12. Reddish brown stains and spots on the paint surface.**

When painting new exterior construction where non-galvanized nails have been used, it is advisable to first countersink the nail heads, then caulk them with a top quality, water-based all-acrylic or siliconized acrylic caulk. Each nail head area should be spot primed, then painted with a quality latex coating. When repainting exteriors where nail head rusting has occurred, wash off rust stains, sand the nail heads, then follow the same surface preparation procedures as for new construction.

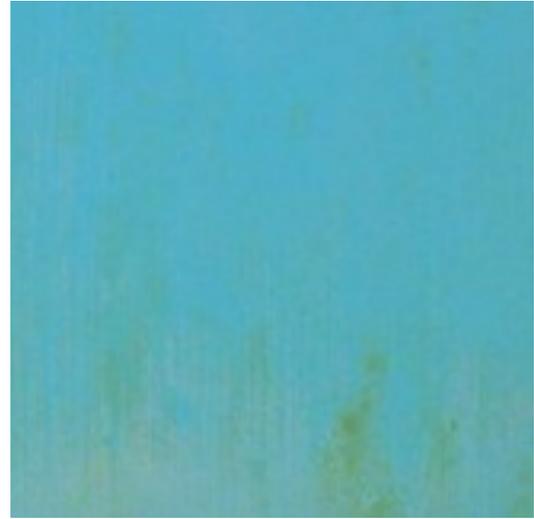
- Coating was applied to new masonry that has not cured for a full year.
- Fresh masonry is likely to contain lime, which is very alkaline. Until the lime has a chance to react with carbon dioxide from the air, the alkalinity of the masonry remains so high that it can attack the integrity of the paint film.

**FIGURE 13.** Color loss and overall deterioration of paint film on fresh masonry.

Allow masonry surfaces to cure for at least 30 days, and ideally for a full year, before painting. If this is not possible, apply a quality, alkali-resistant sealer or water-based primer, followed by a top quality 100 percent acrylic exterior paint. The acrylic binder in these paints resists alkali attack.

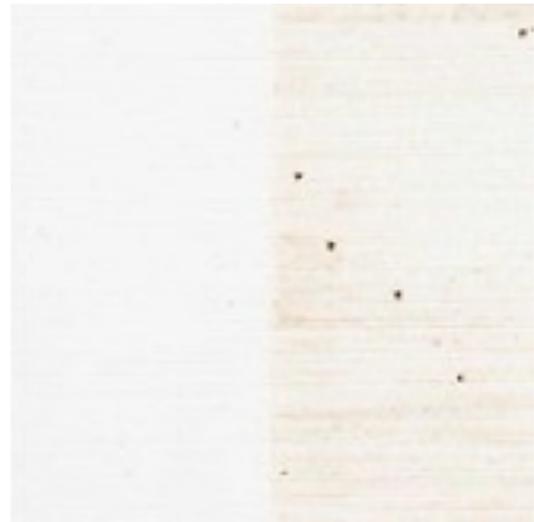
- Failure to adequately prime and seal the surface before applying the paint.
- Use of a primer that is not sufficiently stain-resistant.
- Excess moisture escaping through the exterior walls, which can carry the stain to the paint surface.

**FIGURE 14.** Brownish or tan discoloration on the paint surface due to migration of tannins from the substrate through the paint film. Typically occurs on 'staining timbers,' such as redwood, cedar and mahogany, or over painted knots in certain other timber species.

Correct any possible sources of excess moisture (see Efflorescence and Mottling). After thoroughly cleaning the surface, apply a high quality stain-resistant oil-based or acrylic latex primer. Oil-based stain-resistant primers are the best type to use on severely staining boards. In extreme cases, a second coat of primer can be applied after the first has dried thoroughly. Finish with a top quality latex paint.
